PHYSICAL RESEARCH REPORT NO. 66

INVESTIGATION OF
BRIDGE APPROACH SPANS TO
POPLAR STREET BRIDGE

A Preliminary Study

Floyd K. Jacobsen, Bridge Research Engineer

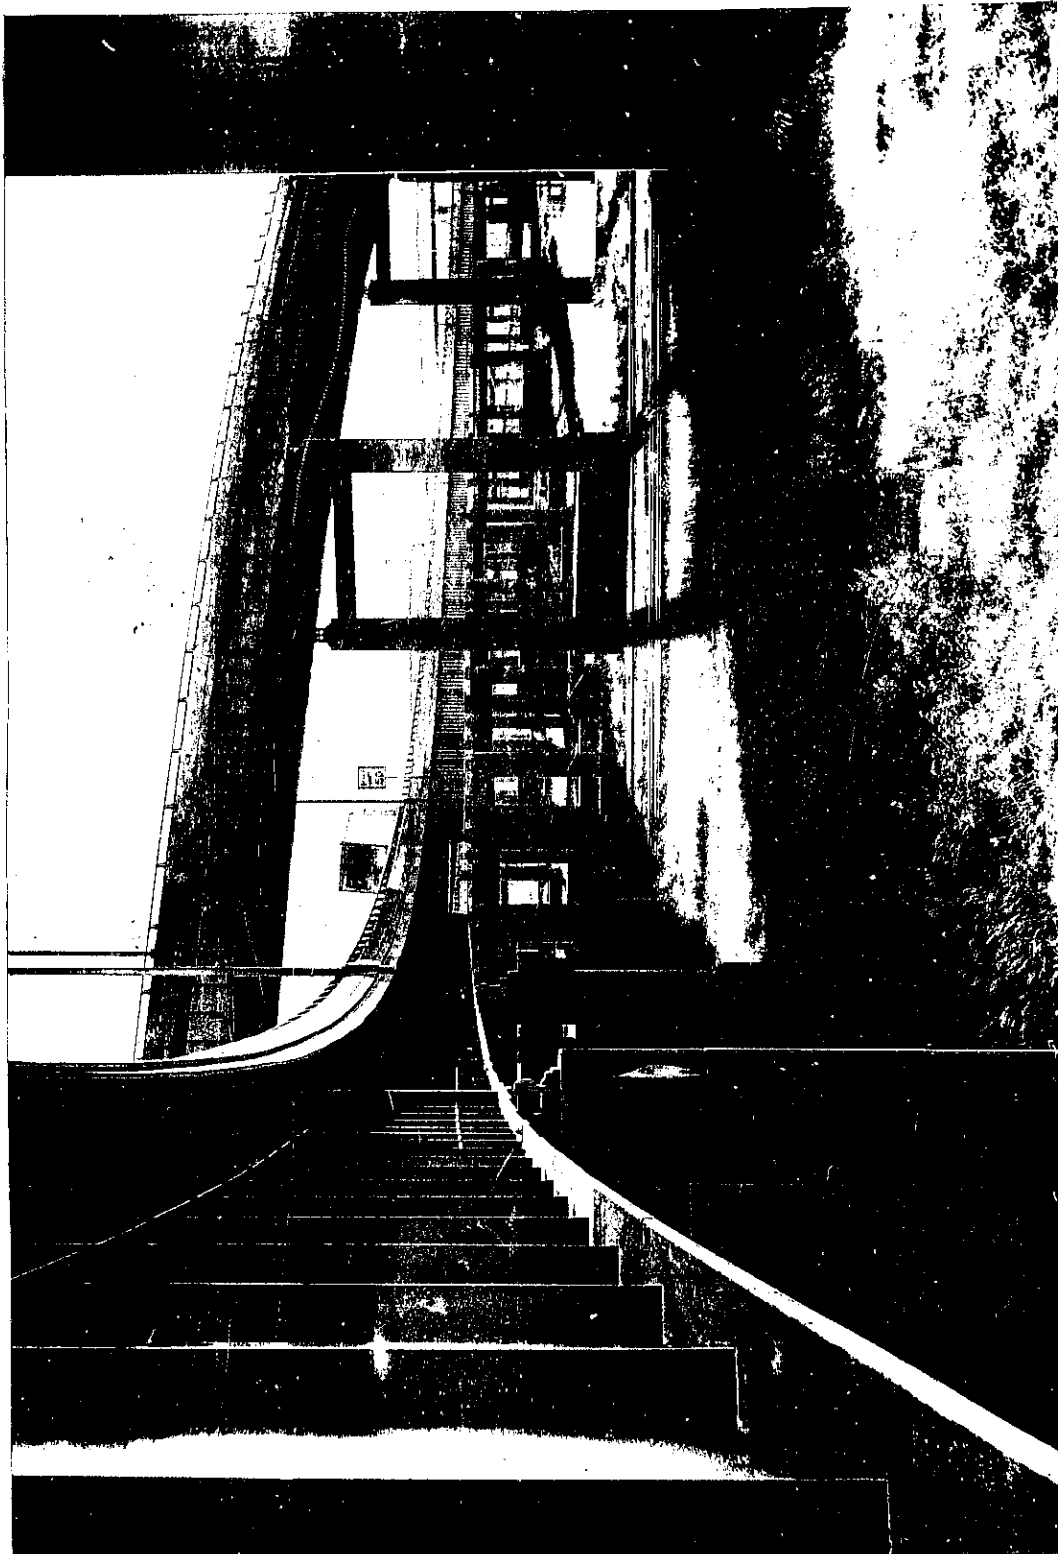
The Poplar Street Complex is one of the largest interchange systems in the State and is located on the east side of the Mississippi River in East St. Louis. It serves two Interstate Highways (FAI 55 and FAI 70) and three major U.S. routes which are combined to cross the Mississippi by the Poplar Street Bridge. The Complex contains over 260 approach spans which are mostly incorporated as a series of three- and four-span continuous units (Figure 1).

Figure 1. General view of Poplar Street Complex.

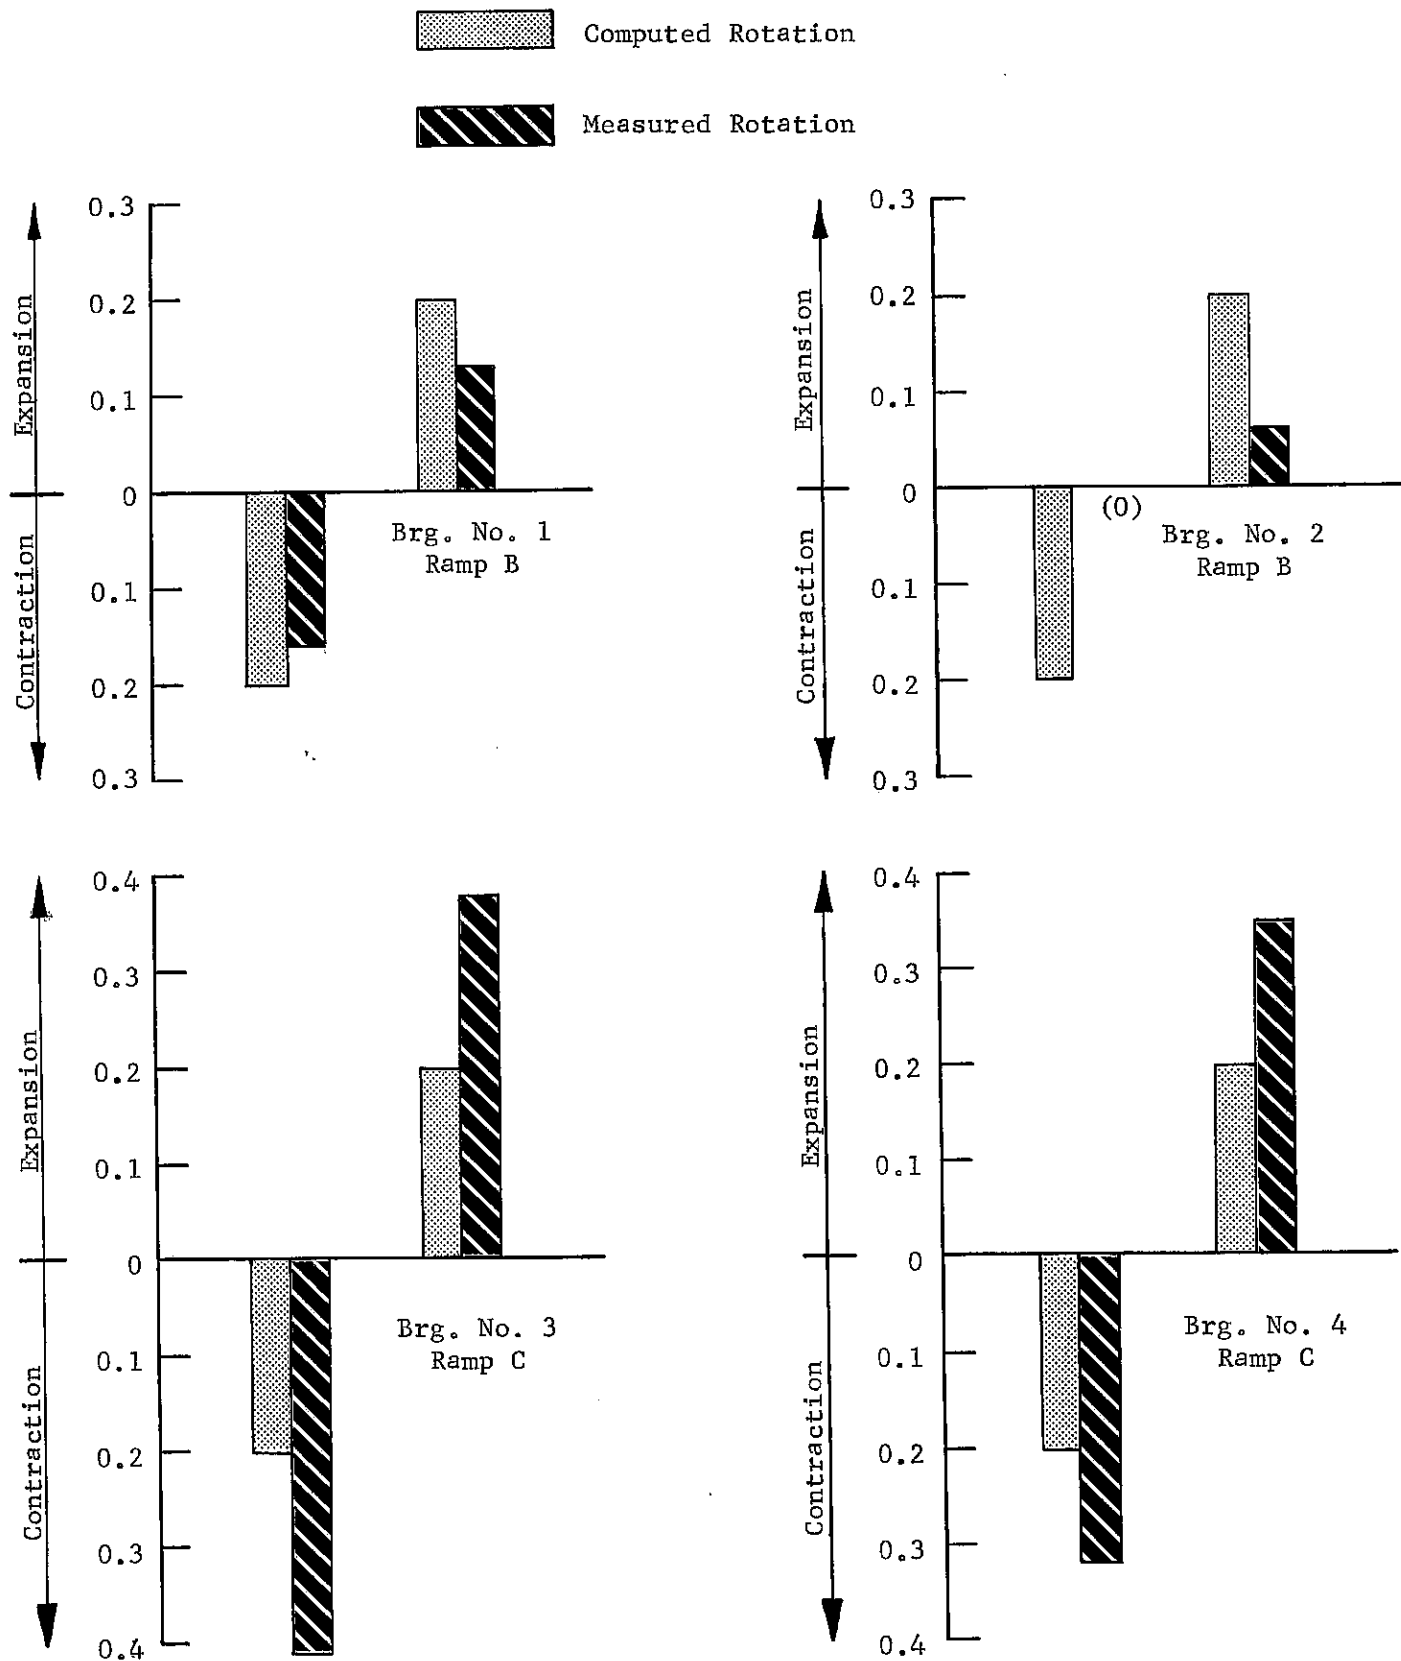
A summary of the movements of the bearings at the east abutment is shown in Figure 3 and 4. A plot of the measured rotations relative to the theoretical values indicates that little or no rotational movement is occurring at the south bearing of Ramp B, identified as bearing 2 (Figure 3). However, the measured expansions for the same bearing as shown in Figure 4 indicates that some movement had taken place between the girder and the abutment. It is believed that this movement was translated through the assembly by slippage between the rocker and the bottom base plate.

Figure 3. Measured rotation versus computed rotation.

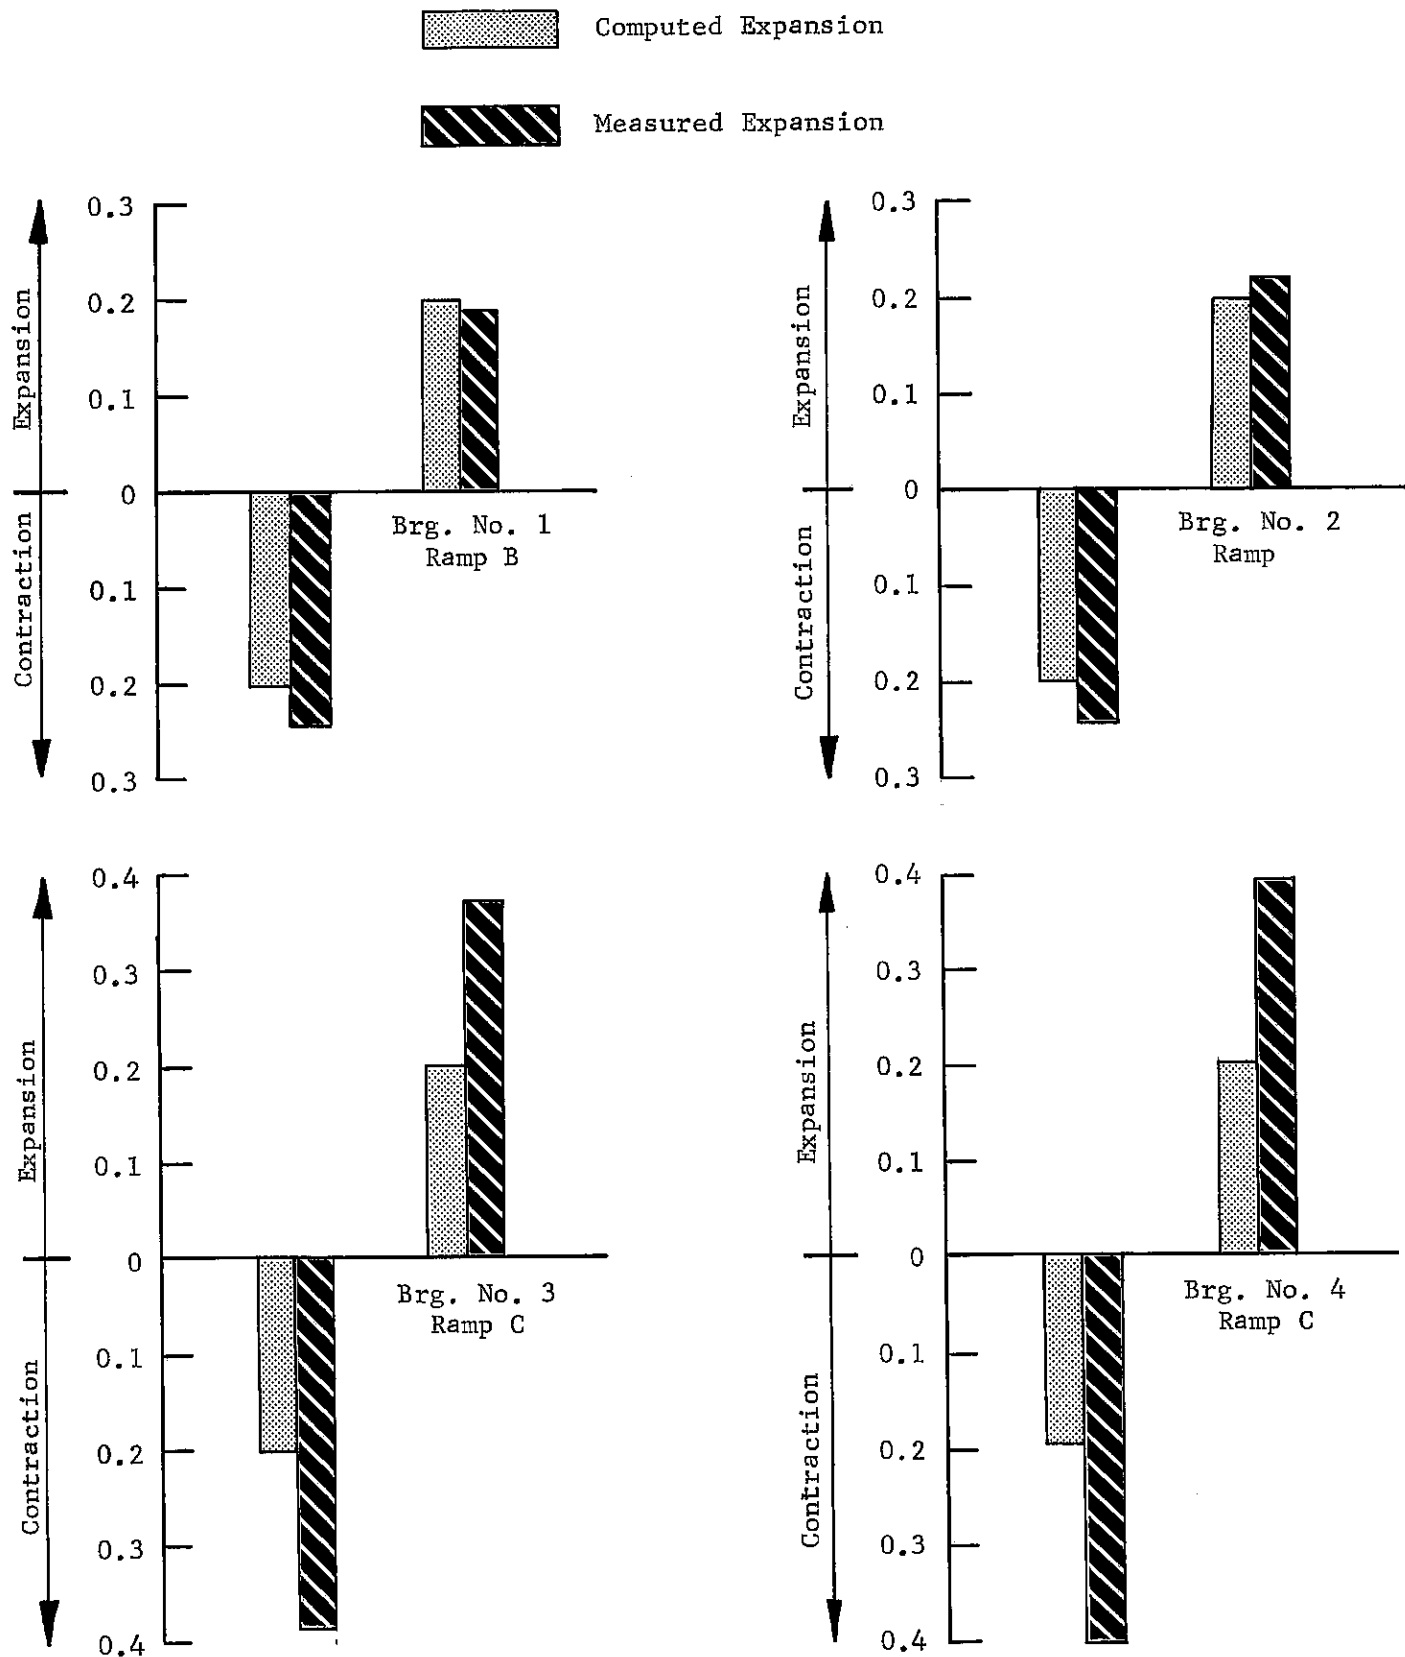
Figure 4. Measured expansion versus computed expansion.

The measured rotations of the bearings No. 3 and 4 at Ramp C correspond favorably with the expansion measurements, which indicate that these bearings are free to rotate under normal temperature changes. The data also show that the measured rotations and expansions are approximately twice the theoretical values based on a 90 ft expansion length from the adjacent fixed pier. This difference between the theoretical and measured values may have resulted from some movement occurring at the fixed pier.

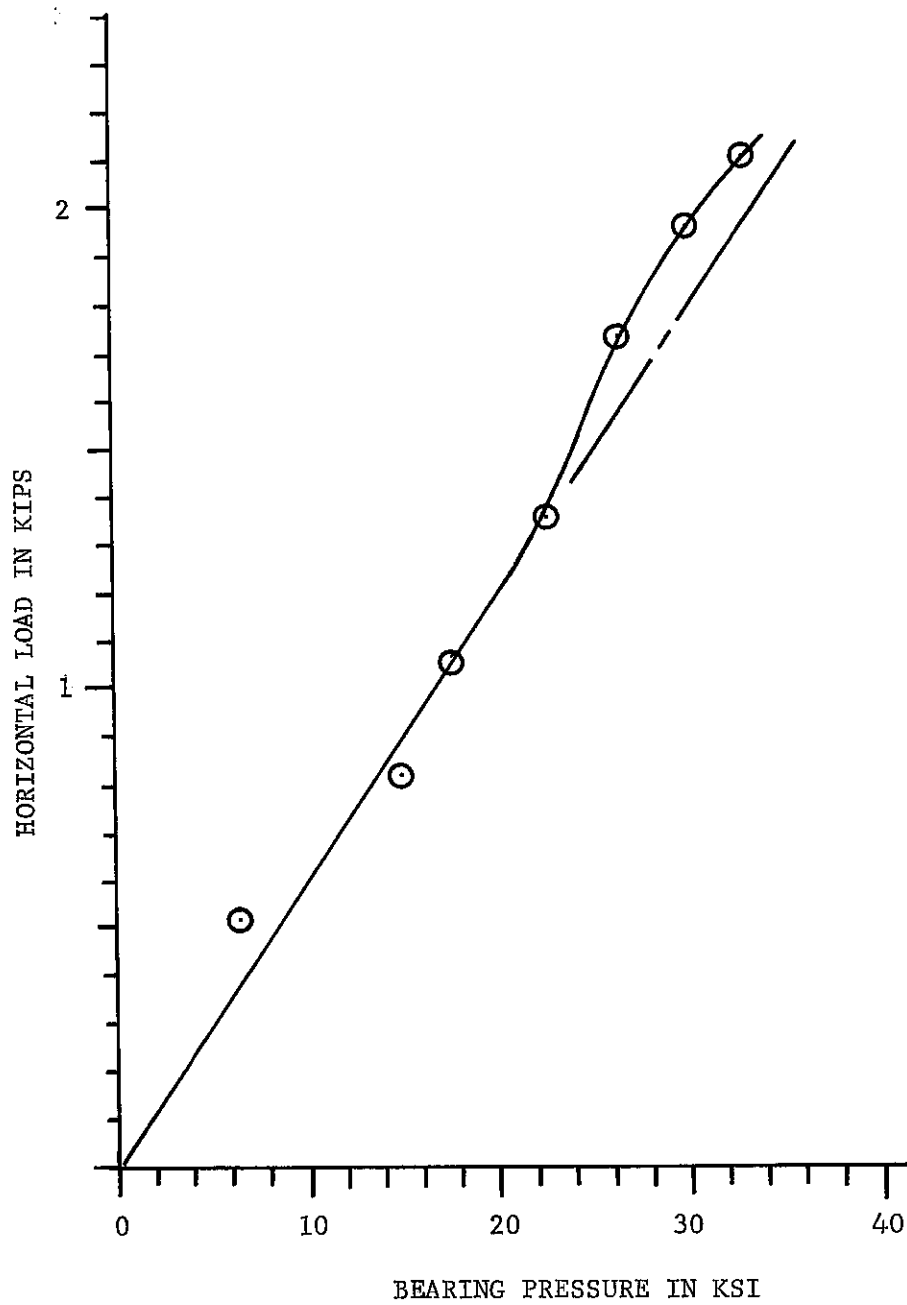
The first test was performed by applying a series of vertical loads through the top of the bearing assembly. Loads were applied in increments to a maximum which produced a unit bearing pressure of 33 ksi on the surfaces in contact with the pin and the saddles supporting the pin. The horizontal forces required to rotate the bearing were measured for each of the corresponding increments of applied vertical load. The results of the test are plotted on Figure 6.

The plot shows a reasonably uniform increase in the horizontal force for applied vertical pressures up to 22.5 ksi. Beyond this point, there was sharp increase in the

Figure 6. Results of vertical load test of 1/3 size model bearing.

horizontal force required to rotate the bearing. Examination of the pin after completing the test had revealed evidence of galling on both the pin and the saddle as shown in Figure 7 and 8. The galling had produced a build-up of hard, solid material which had a tendency to lock the pin to the supporting saddle.

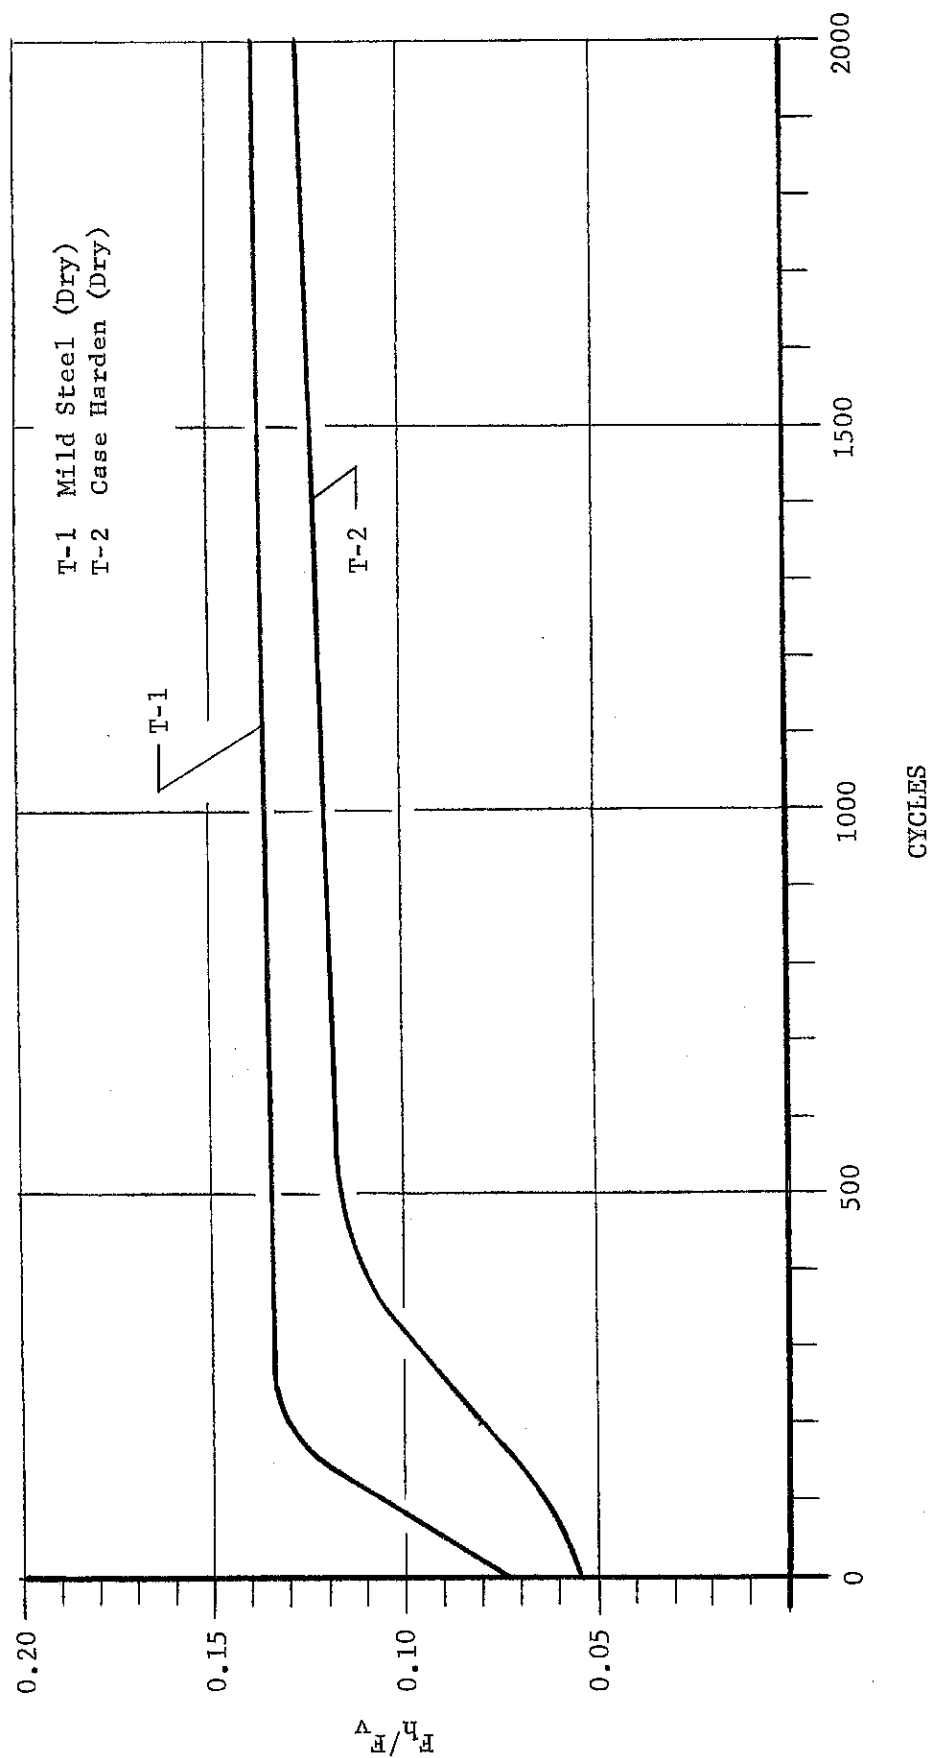
A second test under the same loading pressure, 10 ksi, was conducted with the use of an identical mild steel pin that was case hardened. The amount of wear experience with the case hardened pin was not significant after 2000 cycles of rotational movement (T-2, Figure 9). As a matter of interest, the test had shown also that the coefficient of friction of the case hardened pin was only slightly lower than the coefficient for the mild steel pin with no surface treatment (Figure 10).

Figure 10. Coefficient of friction of dry, mild and case hardened pins.

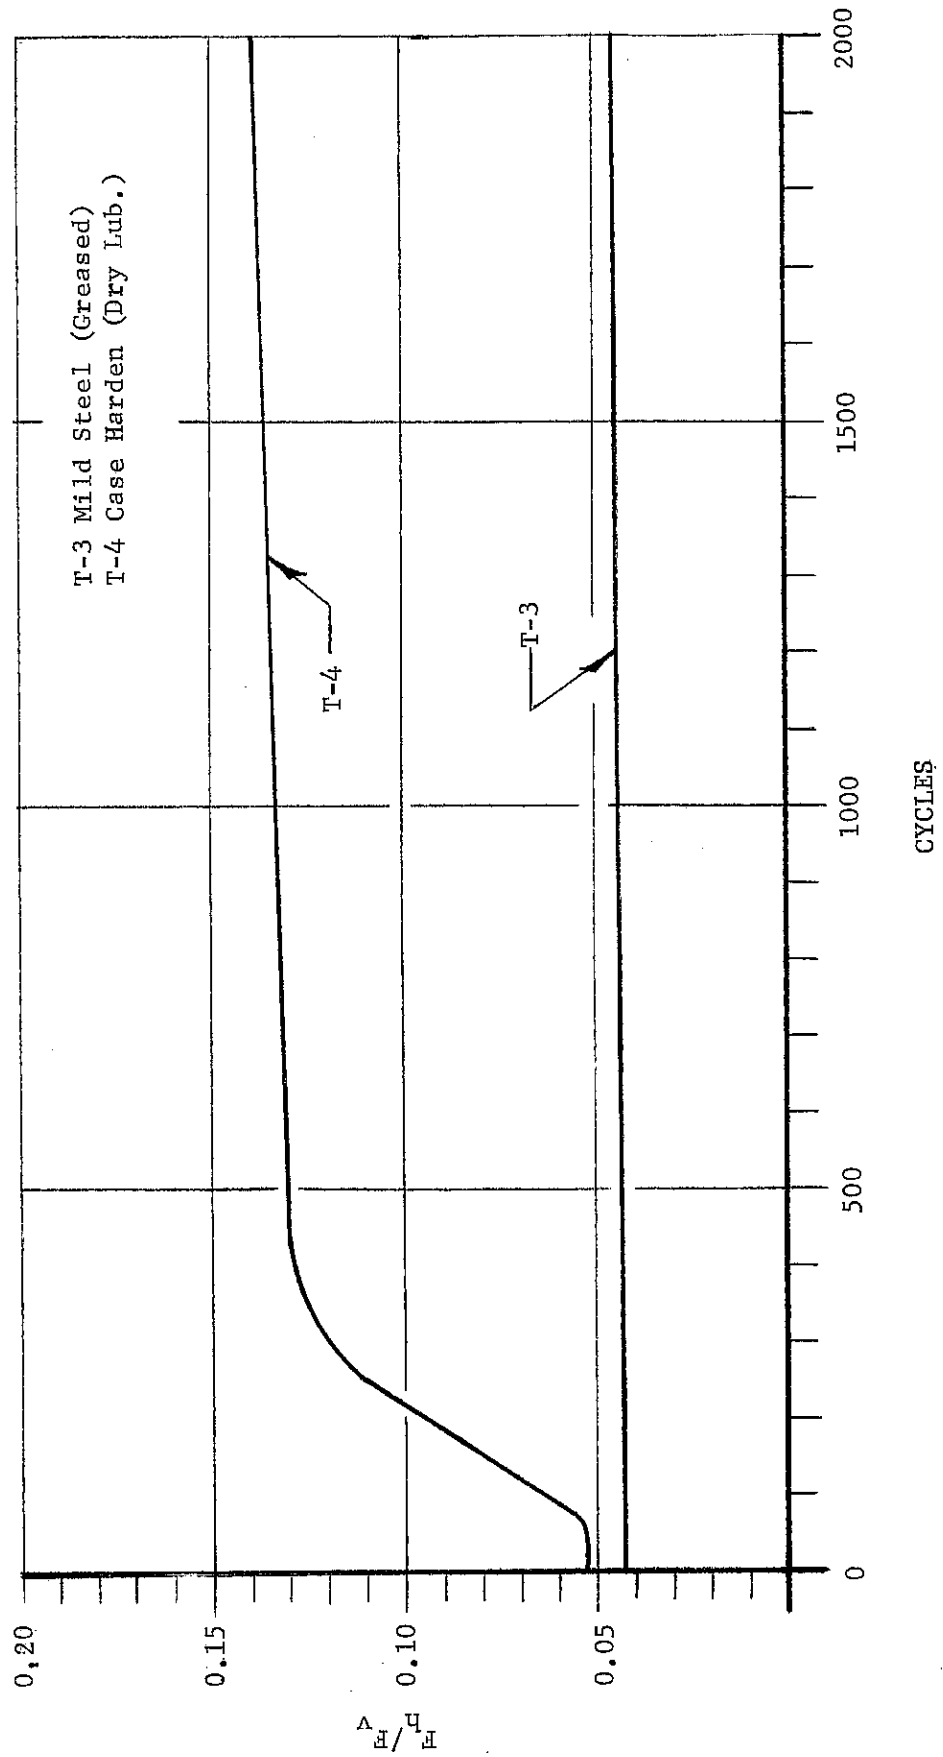
A third specimen which was tested under the same conditions was a mild steel pin with no surface treatment but lubricated with a heavy duty grease. After 2000 cycles, galling to some extent was evident as shown in Figure 9 as T-3. However, the galling was limited to only a small area at one location on the pin. Although galling had occurred to a slight degree, the coefficient of friction of the pin with the grease lubricate was constant throughout the test and was about one-third of the coefficient obtained without the use of the grease lubricant (T-1 Figure 10 and T-3 Figure 11).

A fourth test was conducted using a case hardened pin with a dry film lubricant. The results of the test showed little or no benefits in the use of this type of lubricant (T-4, Figures 9 and 11).

Figure 11. Coefficient of friction of lubricated, mild and case hardened pins.
